FIG Services LLC d/b/a FOX INSPECTION GROUP
Property Inspection Report # 100223aw
11227 Endicott Lane Houston, TX 77035
(Office) 713.723-3330 (Email) office@foxinspectiongroup.com

PROPERTY INSPECTION REPORT

Concerning: 1717 W. Webster Unit E Houston, Texas 77019
(Address or Other Identification of Inspected Property)

Description: 3 story town home; brick / stucco exterior; metal roof; attached garage.

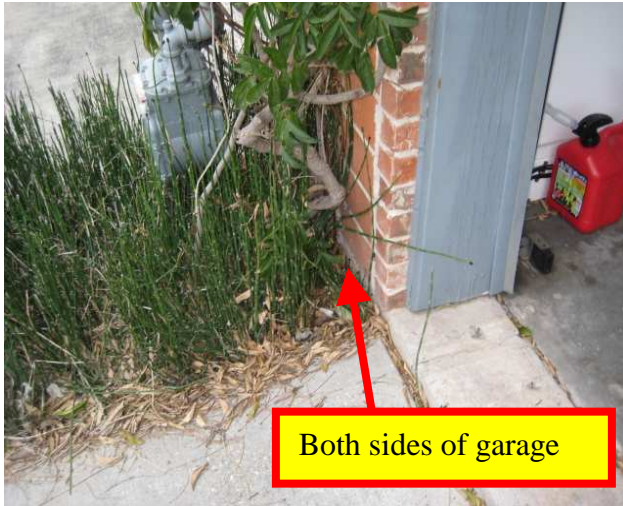
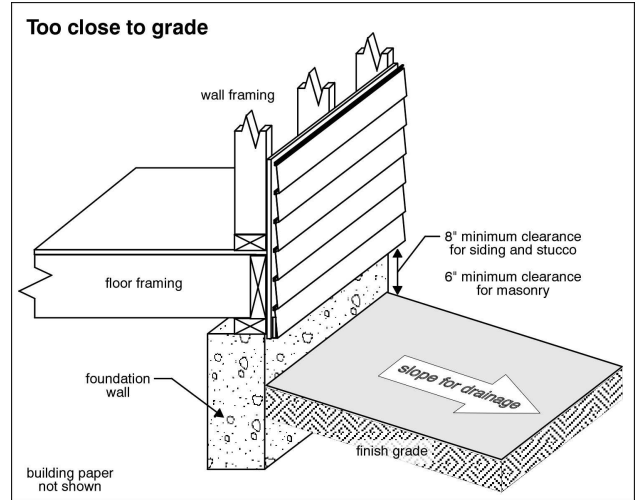
Soil level too high around areas with brick siding at back wall near garage door.
Common industry practice requires a clearance of at least 4 inches from bottom of brick veneer to soil. High soil level near brick siding promotes wood rot and is considered a conducive condition to termite activity and water penetration.

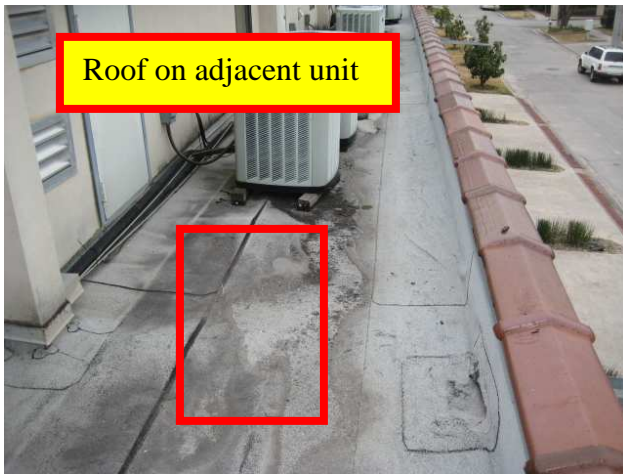
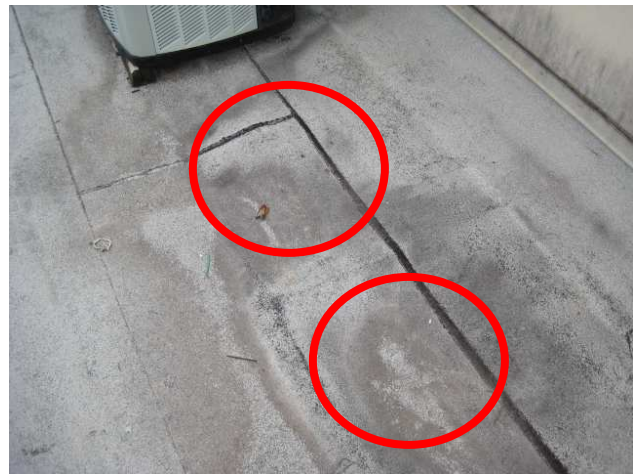
Large bubbled sections of roofing observed around a/c condensing units. Water could be heard moving around bubbled areas when stepped on.

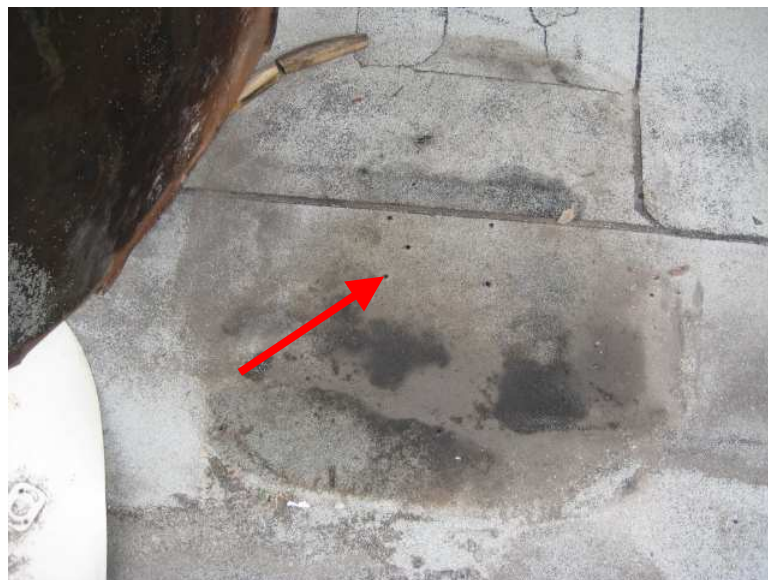
Nail/screw holes observed on roof top near a/c units; area is below a circular section of wood, possibly an old table top. All holes need to be sealed to prevent water entry.

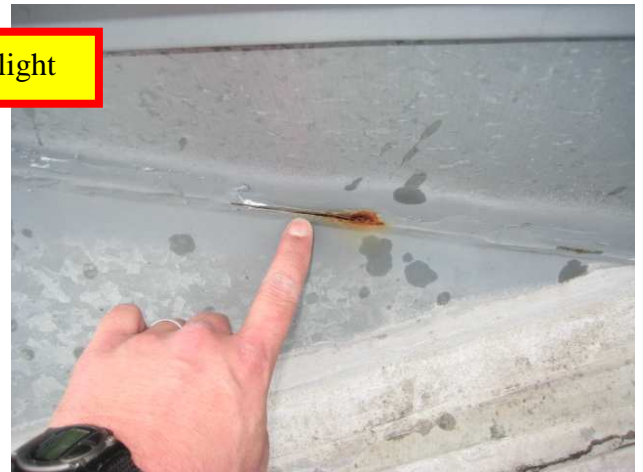
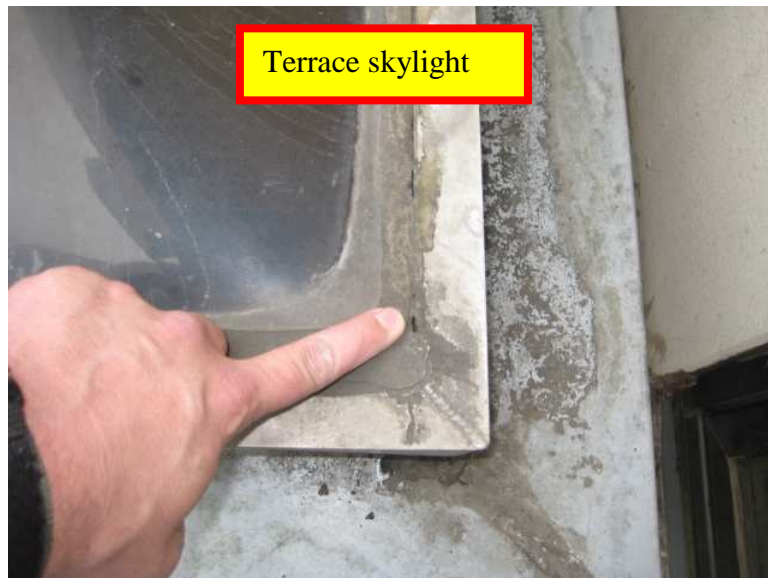
Terrace skylight

Roof skylight(s) are a likely place for water penetration, make sure flashing and glass edges are maintained.

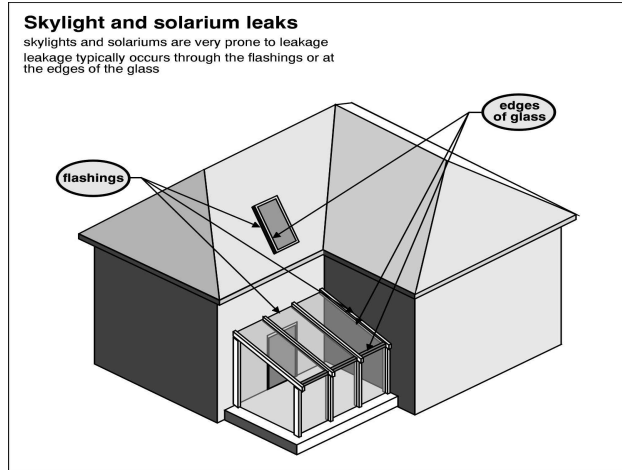
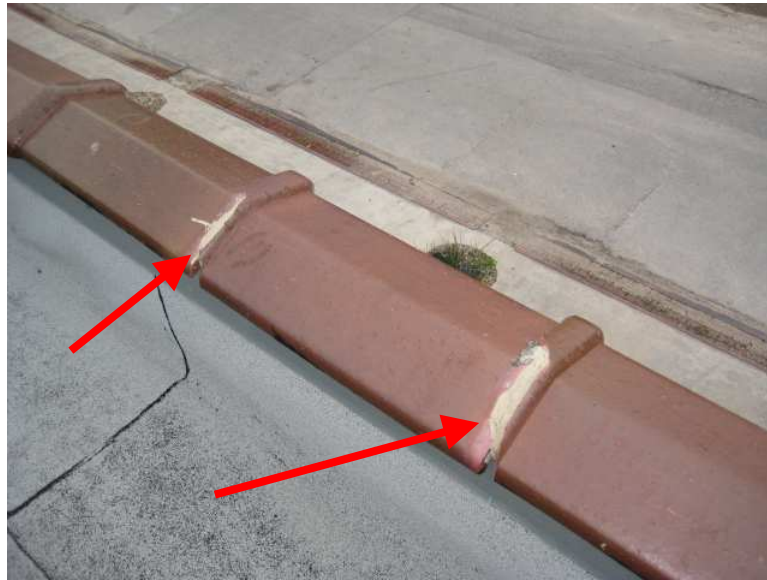
Sections of tiles caps over garage wall near a/c units have been chipped/damaged. Areas have been caulked.

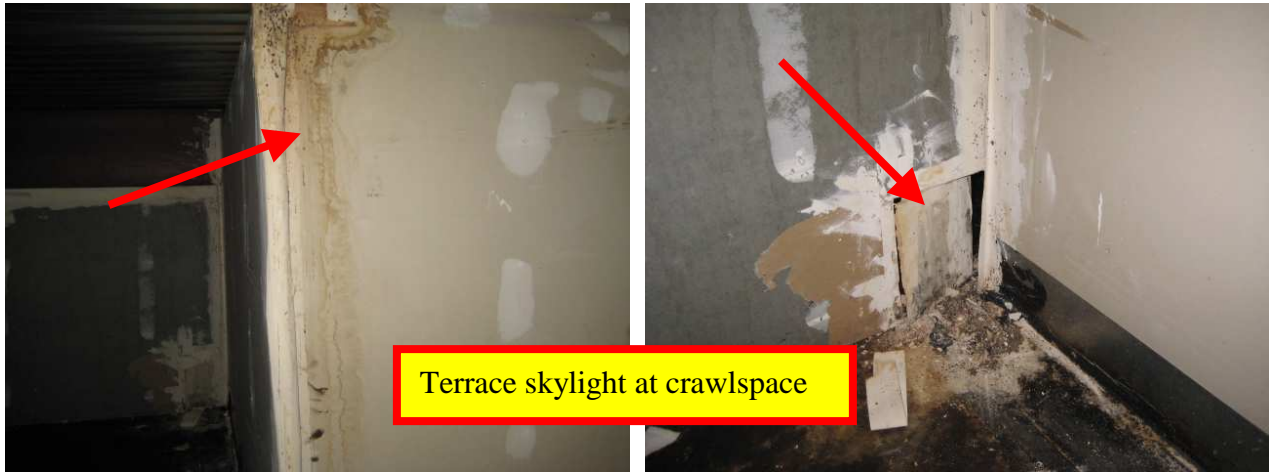
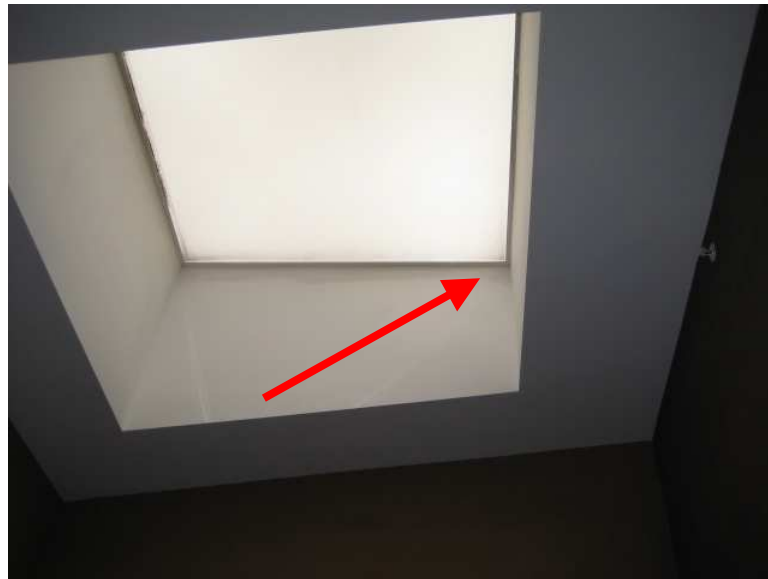
YES!!, Water stains observed around both skylights.

Water stains around skylight over stairway/kitchen area.

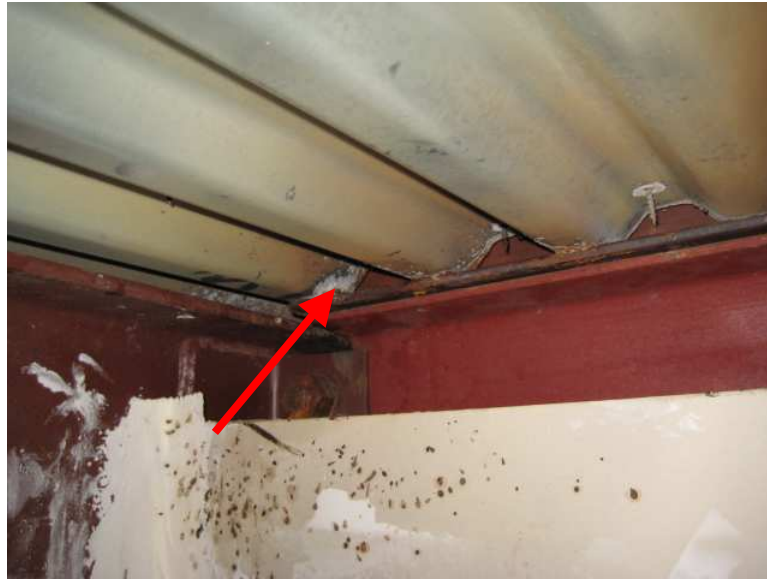
Water stains/corrosion observed on underside of terrace decking near terrace skylight.

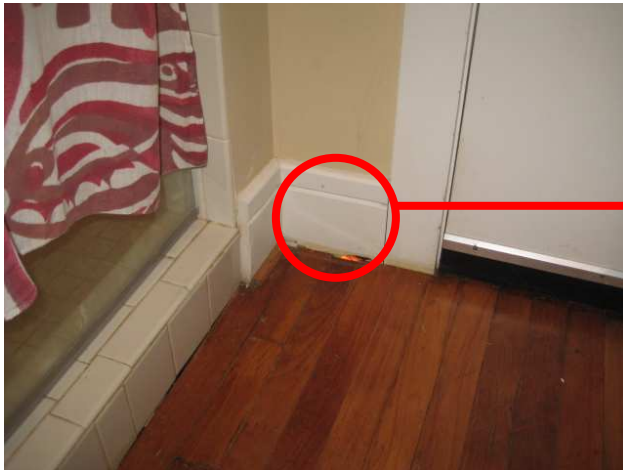
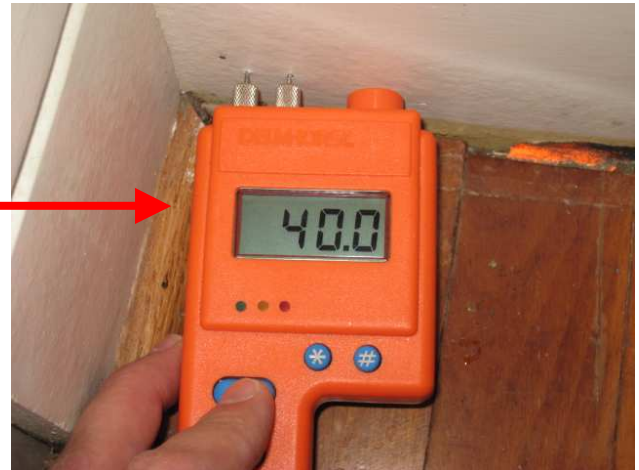
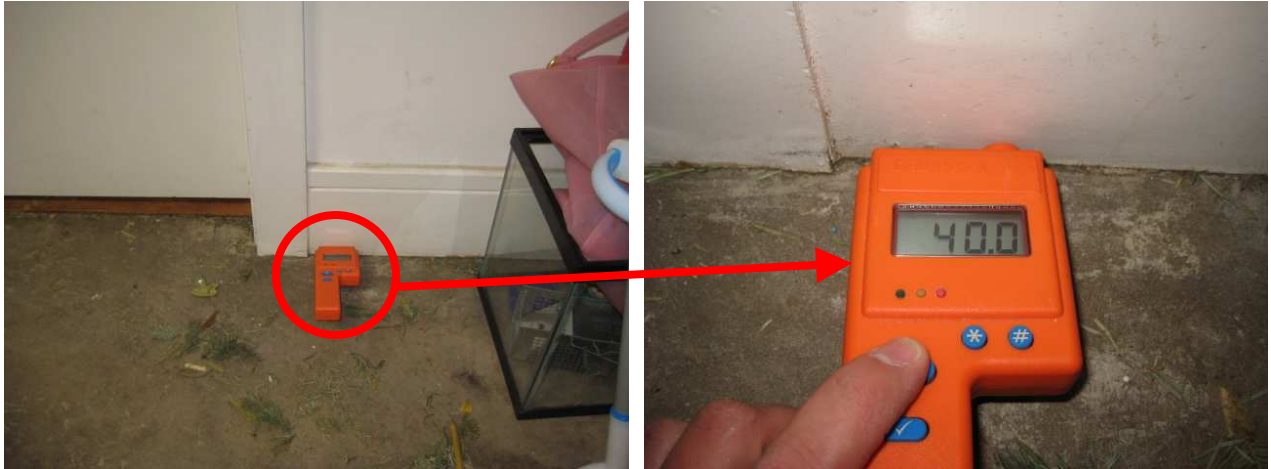
Moisture meter registers water stains as active; around 1st floor bath shower in the house and in the garage. Root cause/source of moisture was not determined.

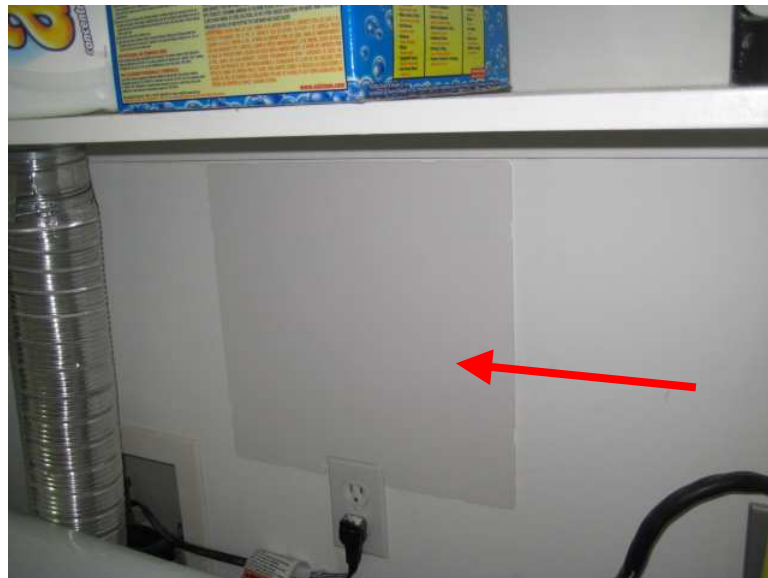
Multiple panels observed on the exterior wall of the laundry room; all panels were not removed; panels have been caulked in place. Recommend inquiry of seller.

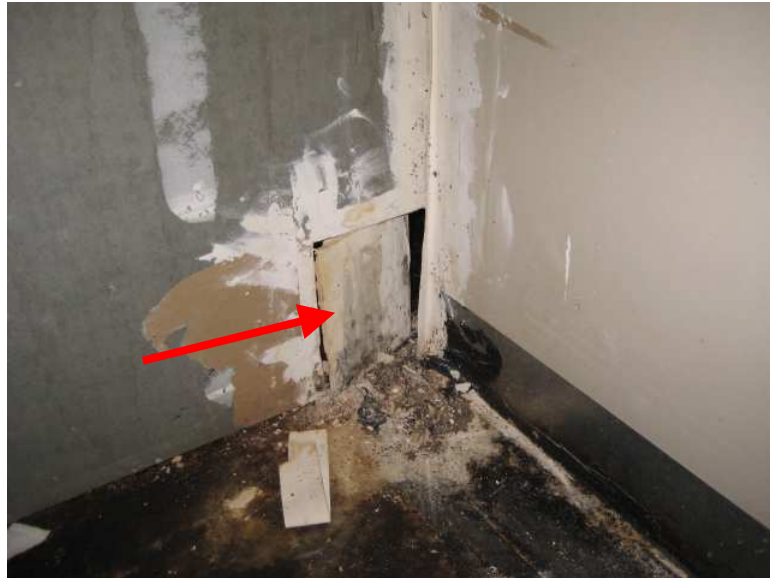
Possible micro-organism growth observed on crawlspace wall near terrace skylight.

Recommend repairing holes that have been cut in the sheetrock around the terrace skylight in the crawlspace.

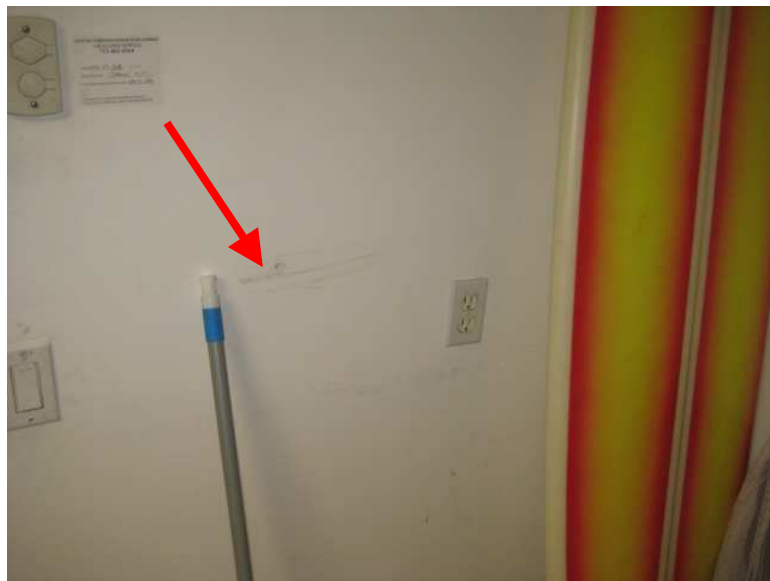
Water stain observed on garage wall that back up to the shower; moisture meter indicated area was dry at time of inspection.

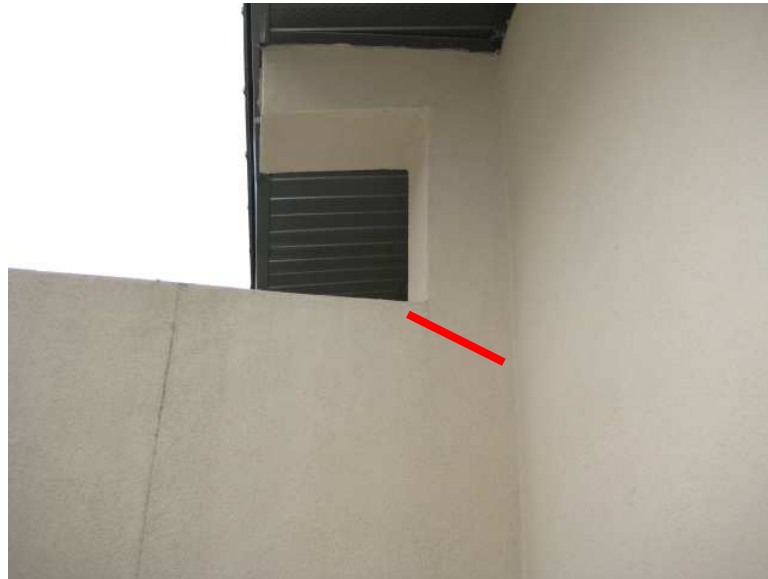
Stains observed on stucco wall at terrace.

Cracks observed at upper sections of terrace walls; recommend sealing cracks to prevent water entry.

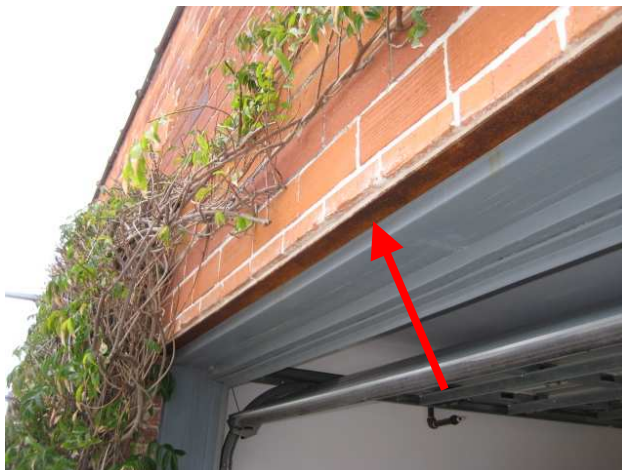
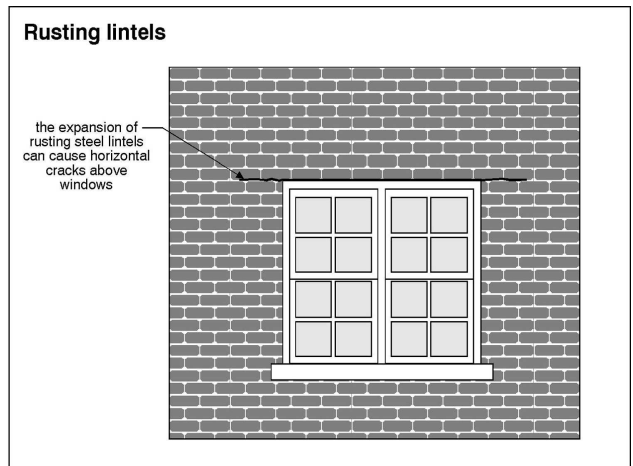
Metal lintel over garage door opening is not painted.

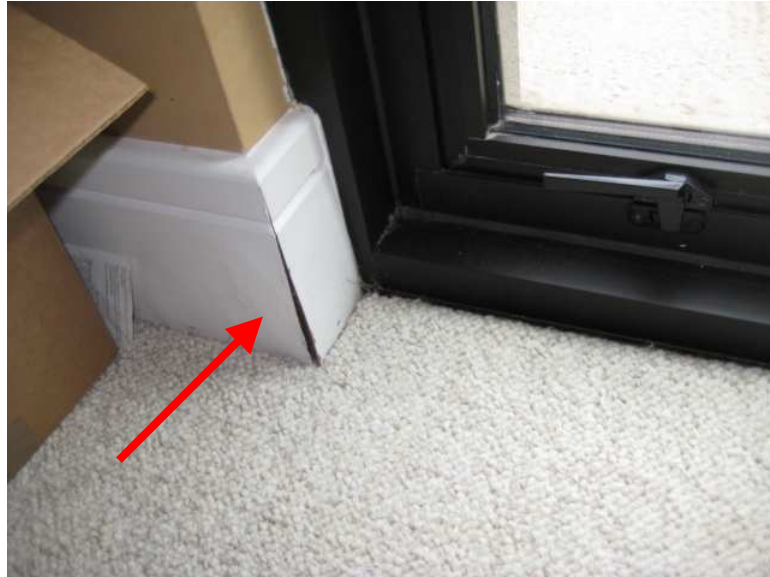
YES!!, Evidence of water penetration observed at lower left master bedroom window. Moisture meter indicated area was dry at time of inspection.

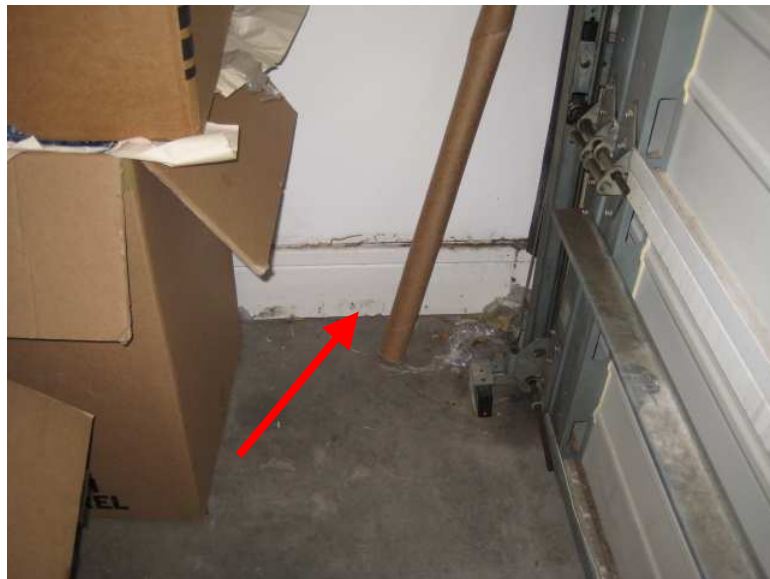
Possible water stains observed on lower corner of garage wall near door; moisture meter indicated area was dry at time of inspection.

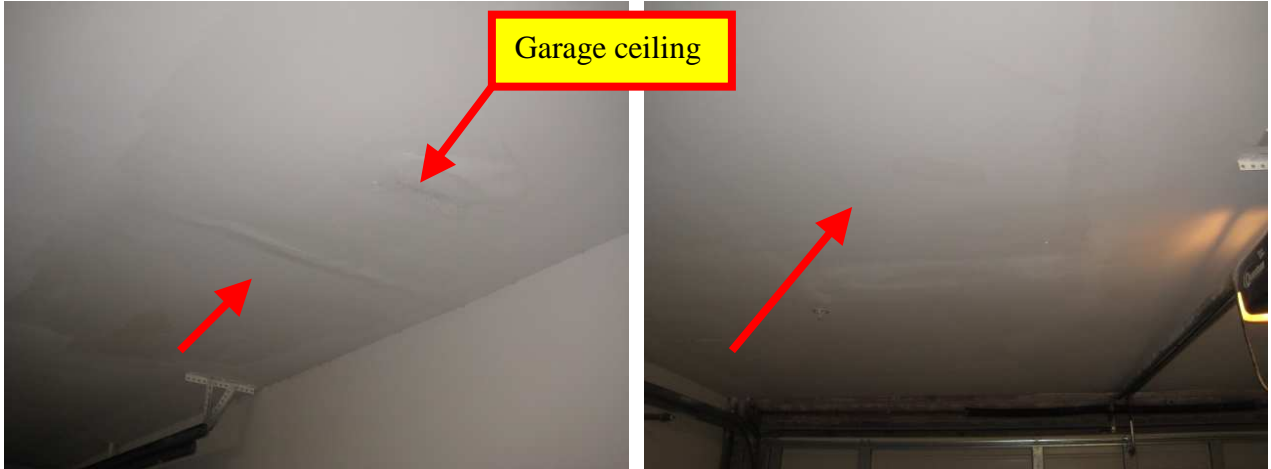
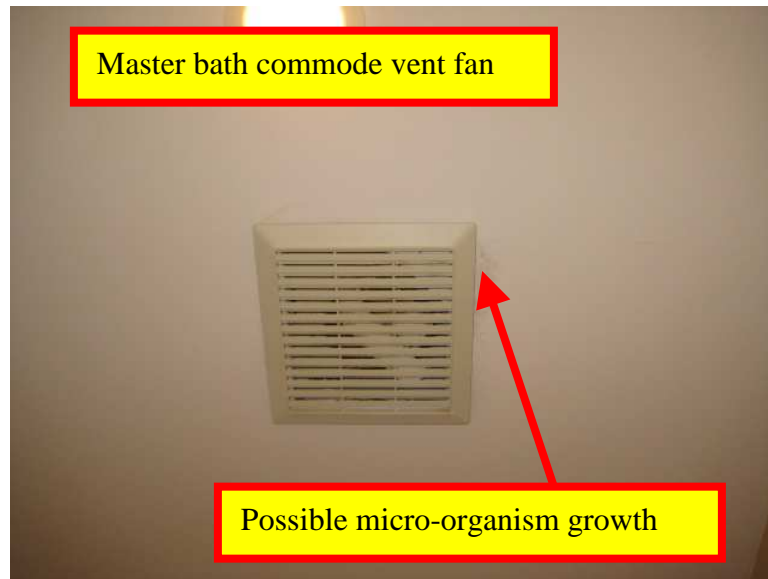
Water stains, damage or repairs observed, moisture detection equipment indicated that stains are not active (wet) at time of inspection; . both sides of garage ceiling (below water heaters and laundry room areas), around the bath fan over the master bath commode.

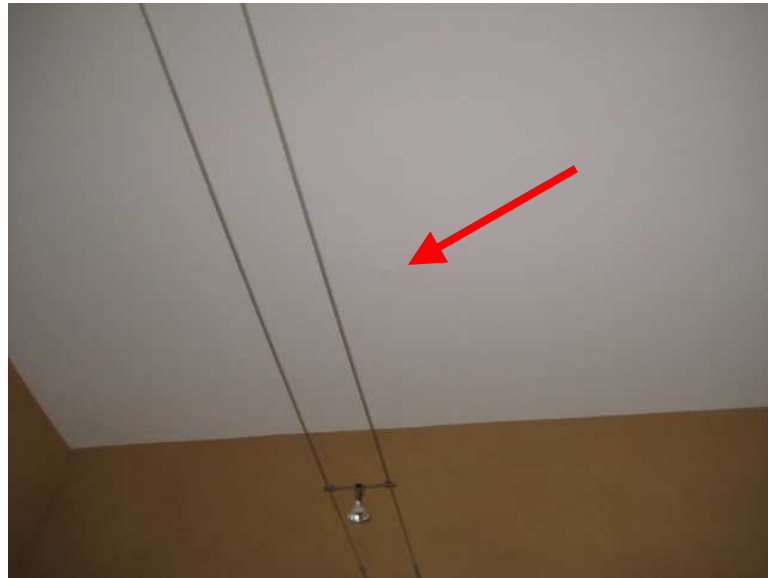
Unknown bubble or nail pop on master bedroom ceiling near lighting; moisture meter indicated area was dry at time of inspection.

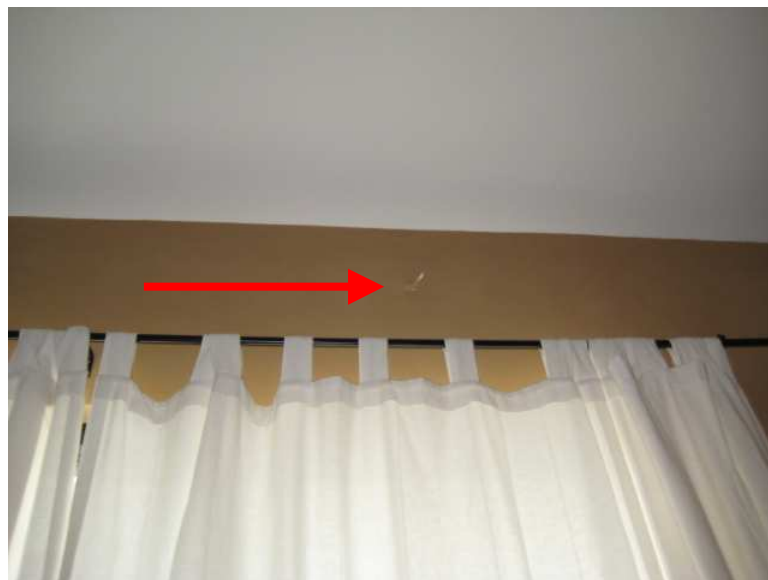
Section of cable has been looped back into wall over master bedroom terrace doors.

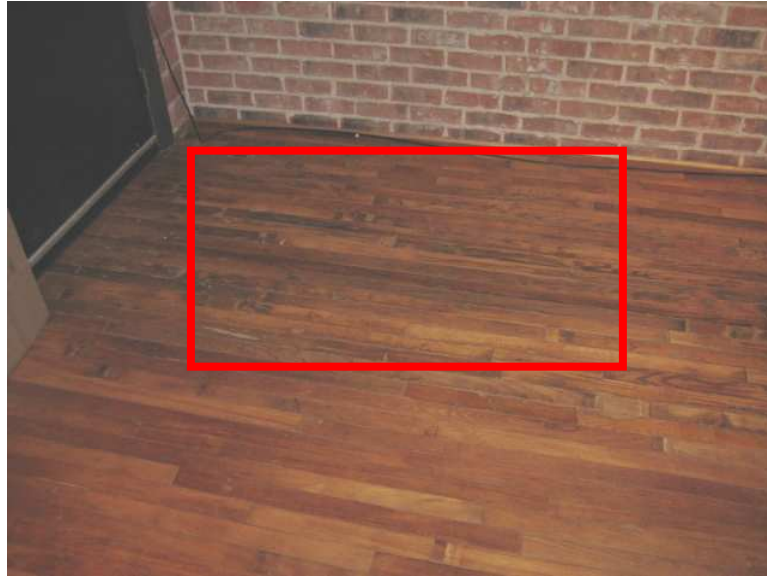
Water damaged wood flooring near front door below skylight.

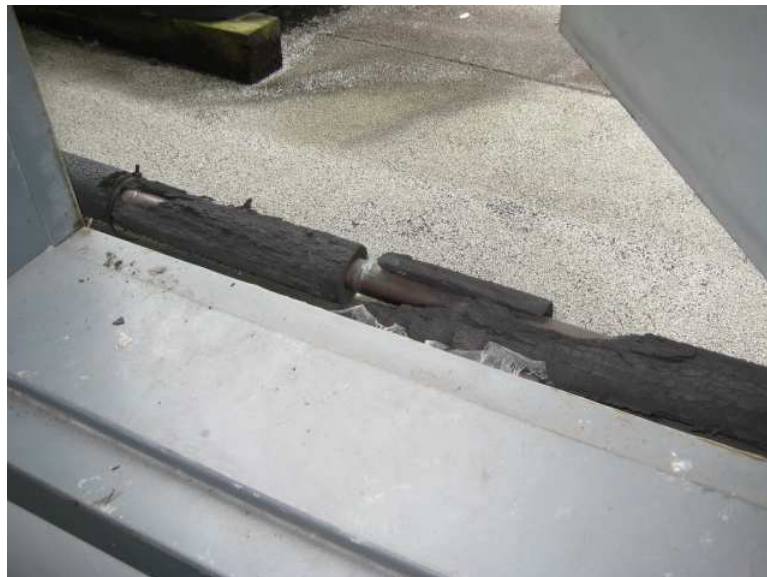
Door to a/c condensing units rubs/damages suction line insulation.

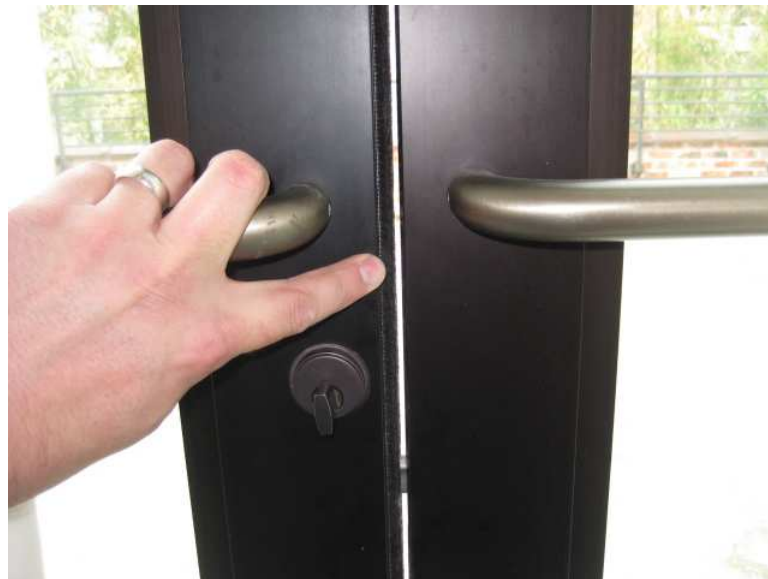
Excessive gap observed between master bedroom terrace doors.

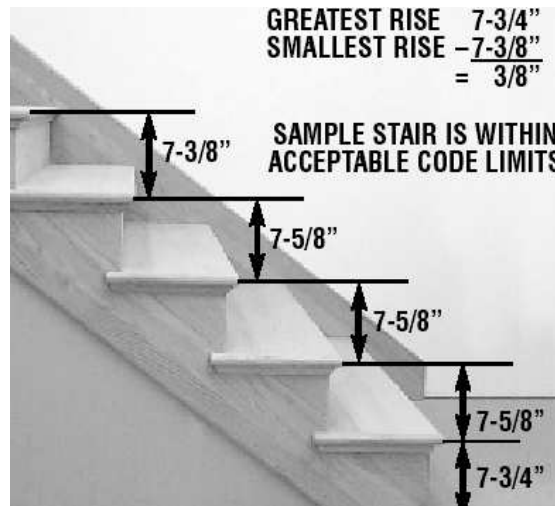
Stairway has tripping hazard, Risers are not same height along the entire height of steps.
Stairway does not comply with current industry standard, (code). CABO 314.2 & UBC 1006.3 requires "The greatest riser height within any flight of stairs shall not exceed the smallest by more than 3/8 inch."

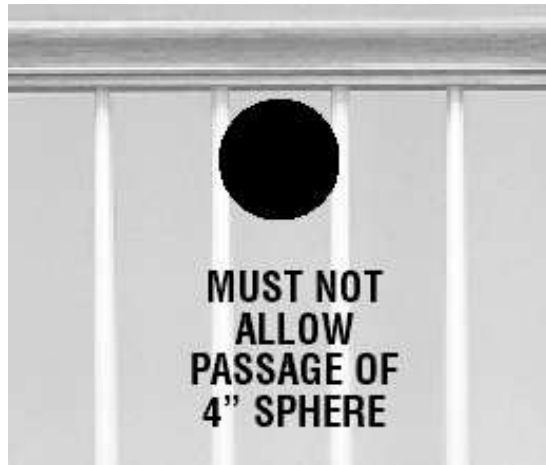
Space between railings does not comply with current industry standard, (code) UBC 421.1.1 & CABO D105.2.1. Requires spacing between intermediate rails do not allow passage of an object four inches in diameter. Recommend covering large openings in stair rails with temporary type nylon netting if small children are present in house to prevent injury.

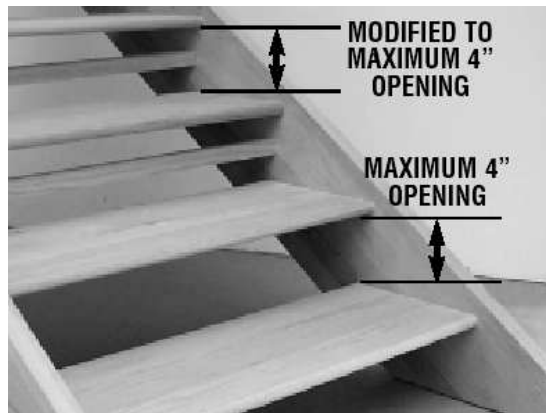
Distance between tread openings shall not exceed 4 inches.

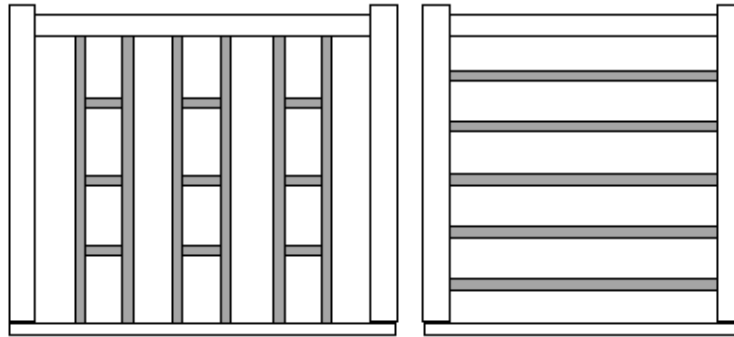
Nautical style railings of stairway and balconies are known to be potential hazard around small children who like to climb the horizontal rails.

**LADDER TYPE DESIGNS
ARE NOT ACCEPTABLE**

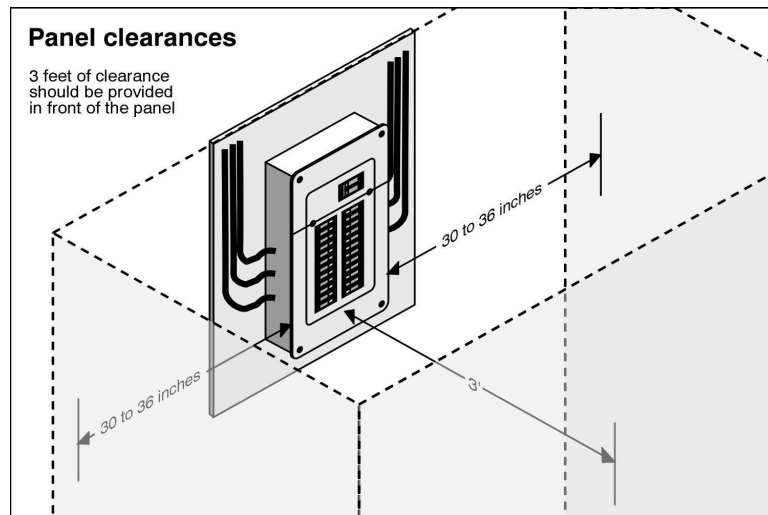
Code requires minimum clearance to electrical service panels to be 36" in front of and 30" from side to side.

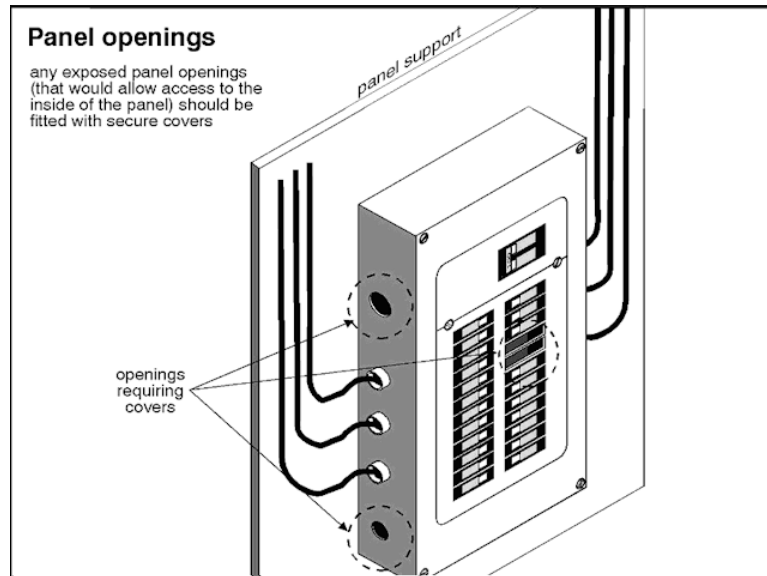
Panel circular knock out in bottom of panels need to be sealed to comply with proper fire-stopping.

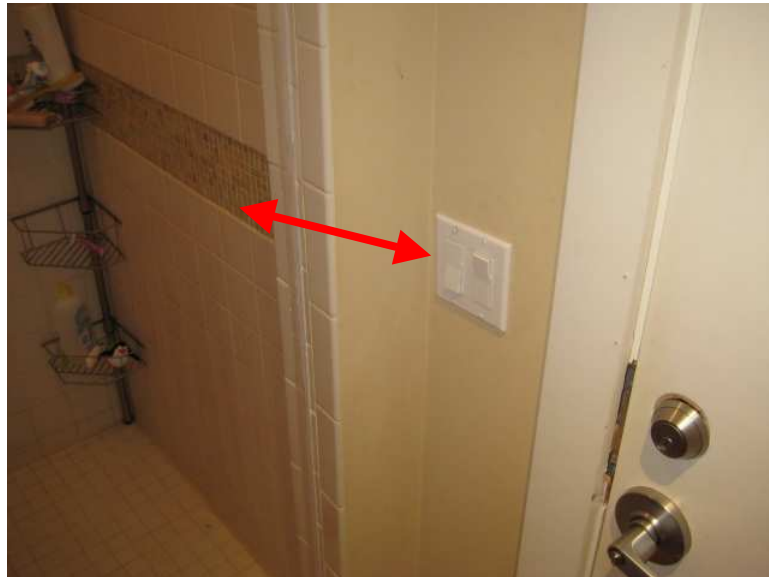
Switch can be operated while standing in 1st floor shower, shock hazard.

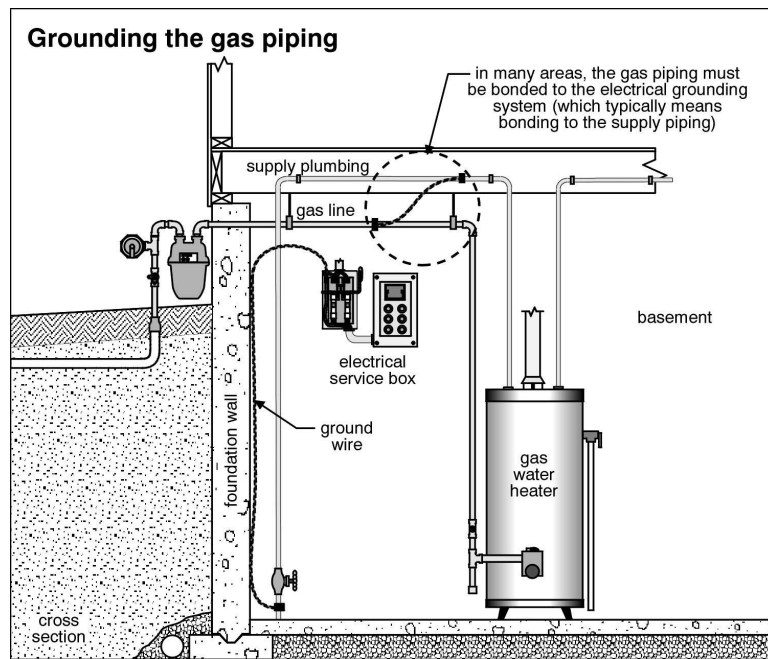
Gas and hot / cold water lines are not properly bonded near water heater. Does not comply with most recent electrical code. NEC 250-80b.

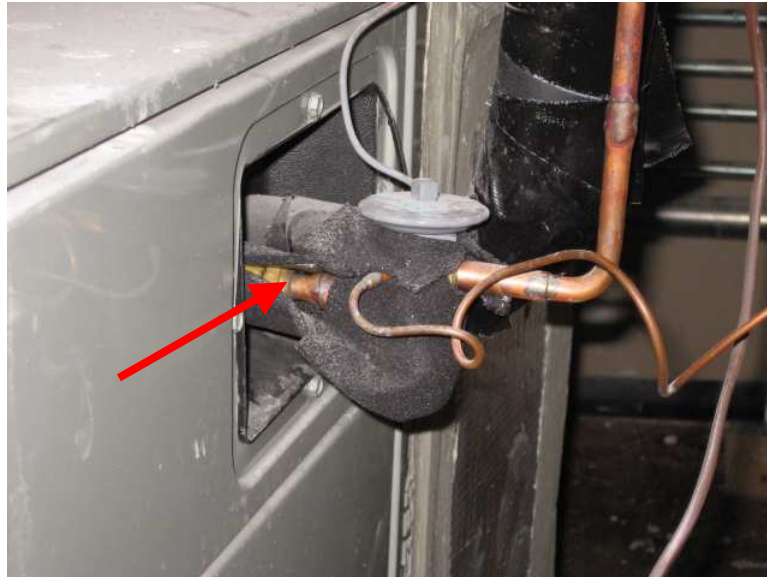
Section(s) freon line insulation missing in attic near coil. Warm air condenses on cold expansion valve and drips condensation.

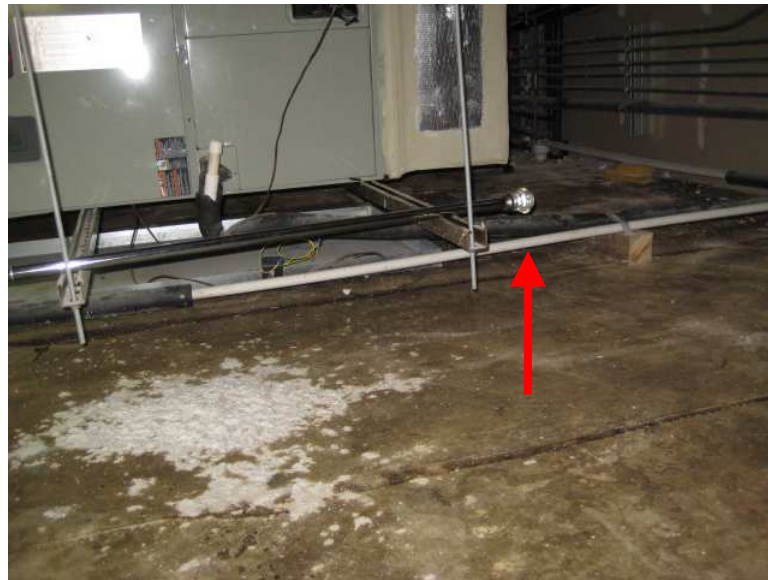
Primary drain line elevation improper, repair.

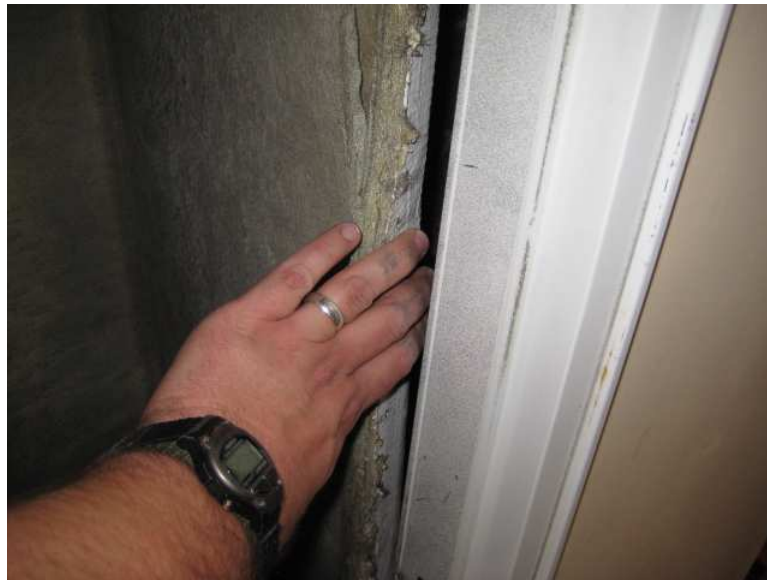
Return air chase is not properly sealed outside the master bedroom. This condition results in very significant reduction of cooling capacity and substantially increased operating costs.

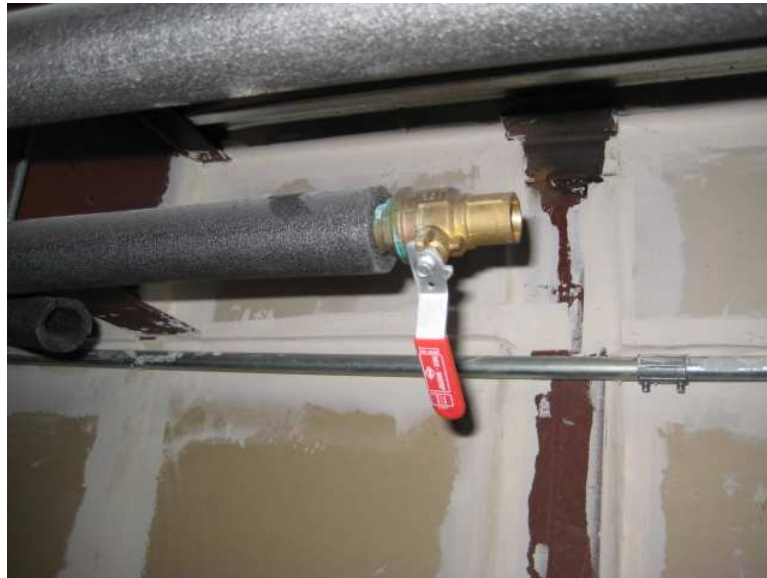
Hot water line below kitchen prep sink was turned off; recommend inquiry of seller.

Recommend capping section of hot water line in crawlspace if it will not be used.

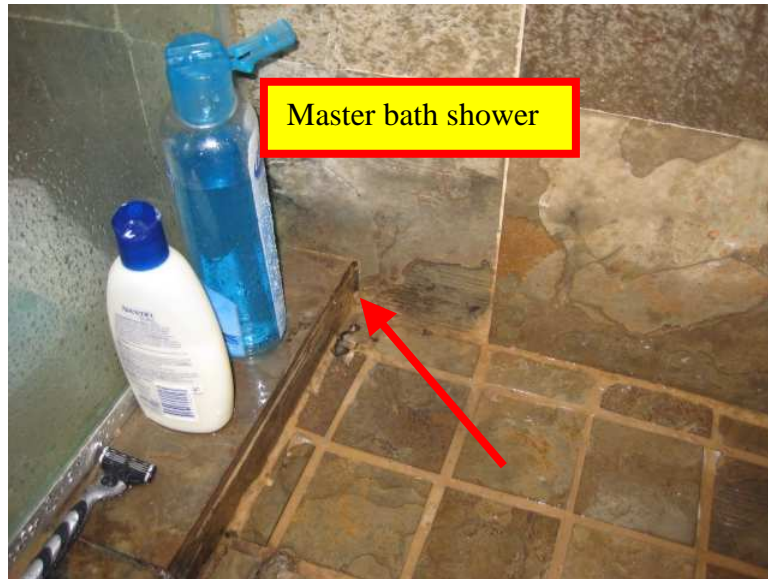
Grout / caulking needed at vertical tile corners, cracks/gaps in tile and/or mortar between tiles, to prevent water entry behind wall.

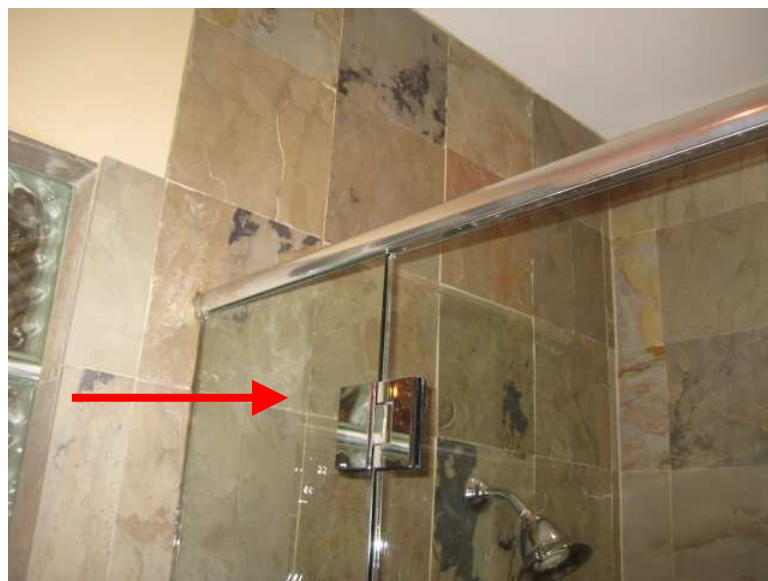
Door handle loose at master bath shower.

Section of glass is loose at master bath shower enclosure.

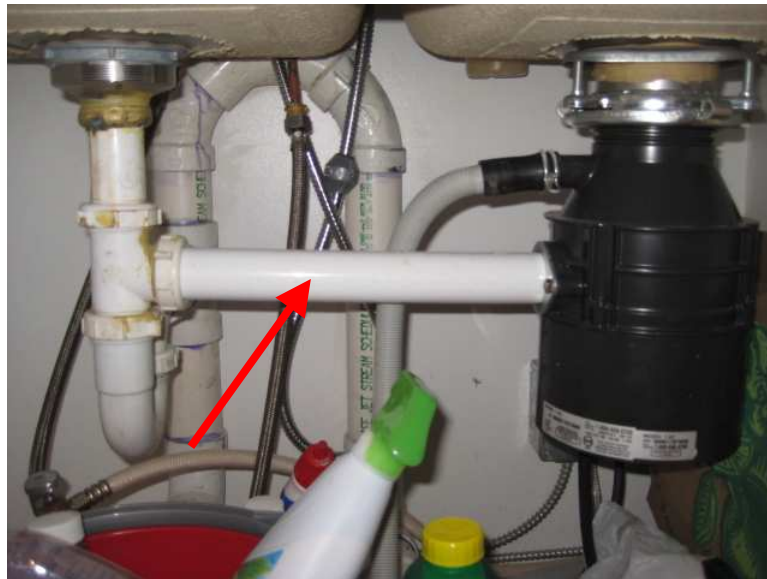
Reverse slope of drain line, does not tilt towards downhill for proper drainage, below kitchen sink.

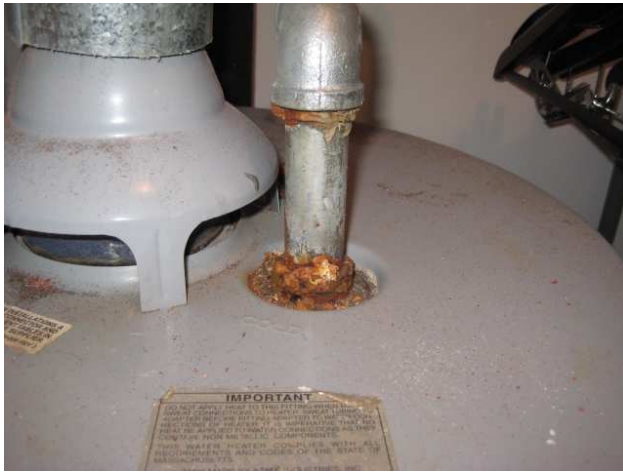
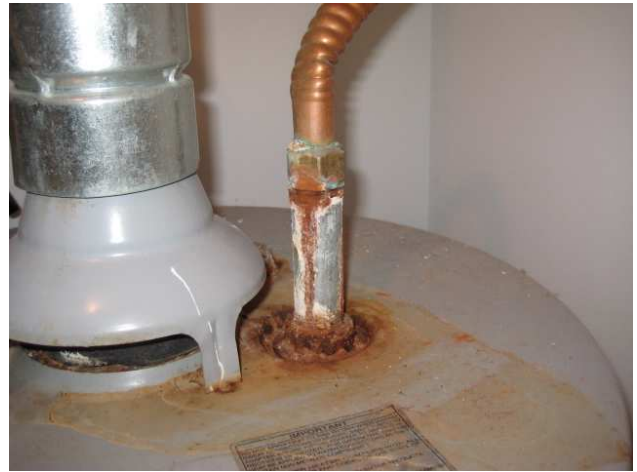
Corrosion observed at shut off valve and/or connections on top of water heaters.

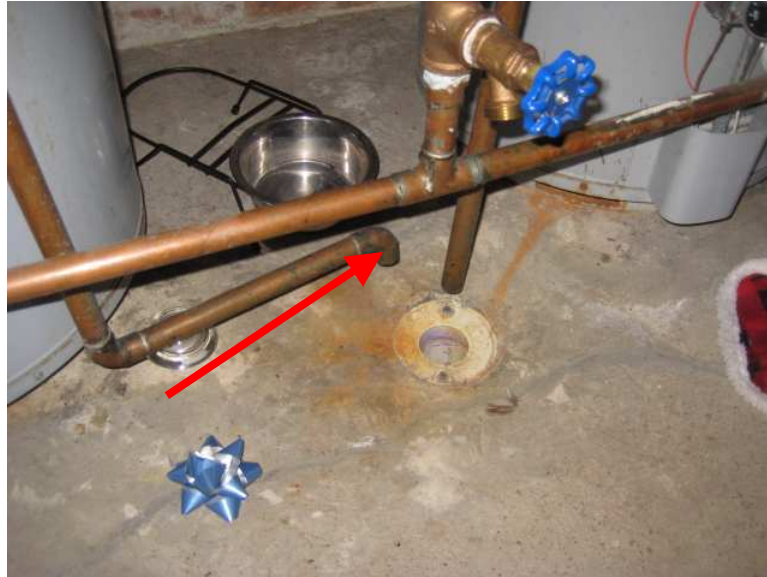
Temperature and pressure relief valve drain line does not line up over floor drain; floor around drain is sloped toward drain.

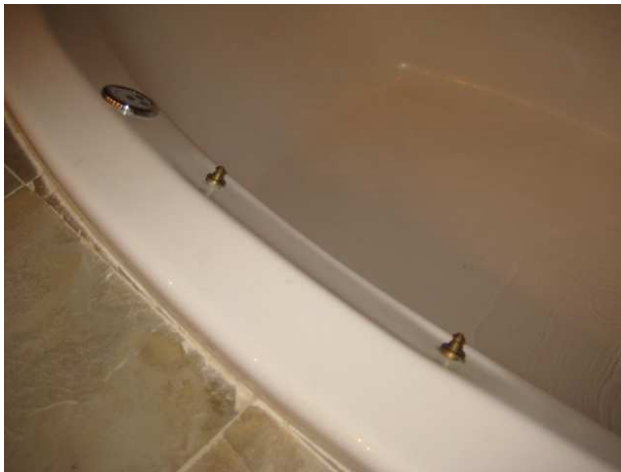
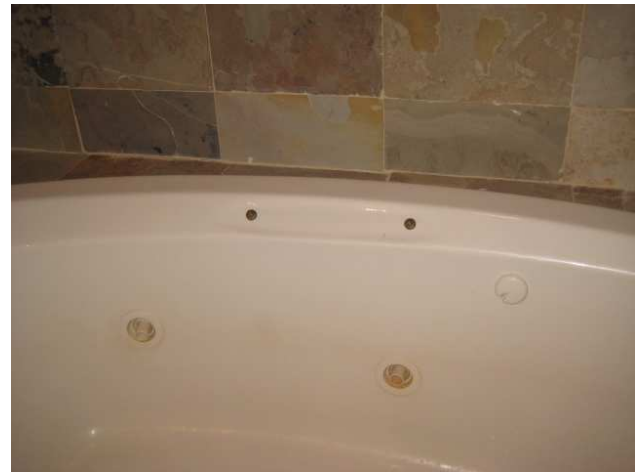
Was not able to access motor for visual inspection. Does not comply with National Electric Code (Reference NEC 680-72. Accessibility). "hydro massage bathtub electrical equipment shall be accessible without damaging the building structure or building finish".)

Unit is possibly missing handles on sides of tub; unknown function of brass fittings.
